BIRDSBORO RESERVOIR

PHASE I INSPECTION REPORT NATIONAL DAM INSPECTION PROGRAM

SEPTEMBER 1978

BIRDSBORO RESERVOIR
BERKS COUNTY, PENNSYLVANIA
NATIONAL I.D. NO. PA 00713

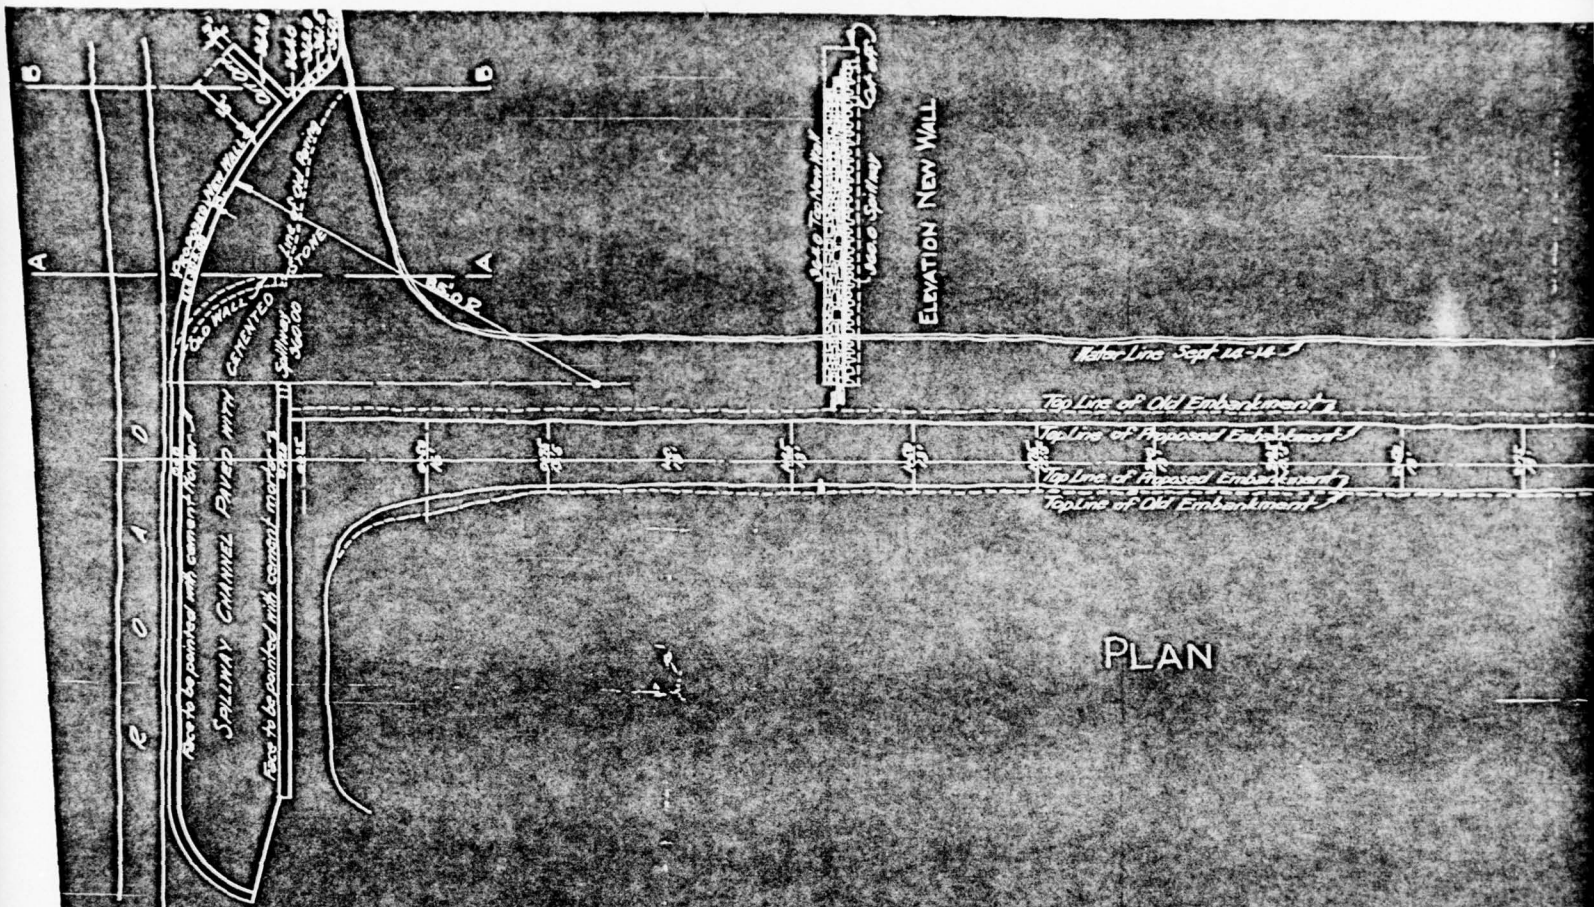
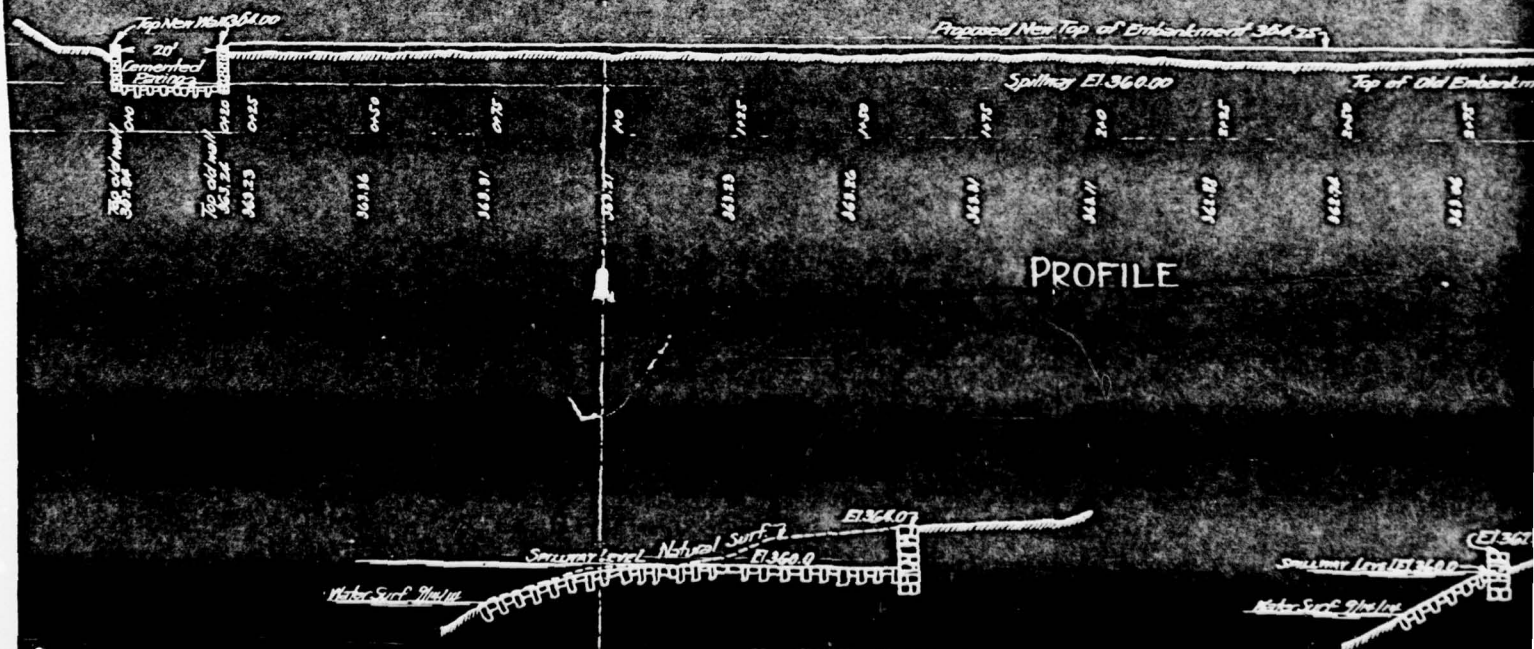
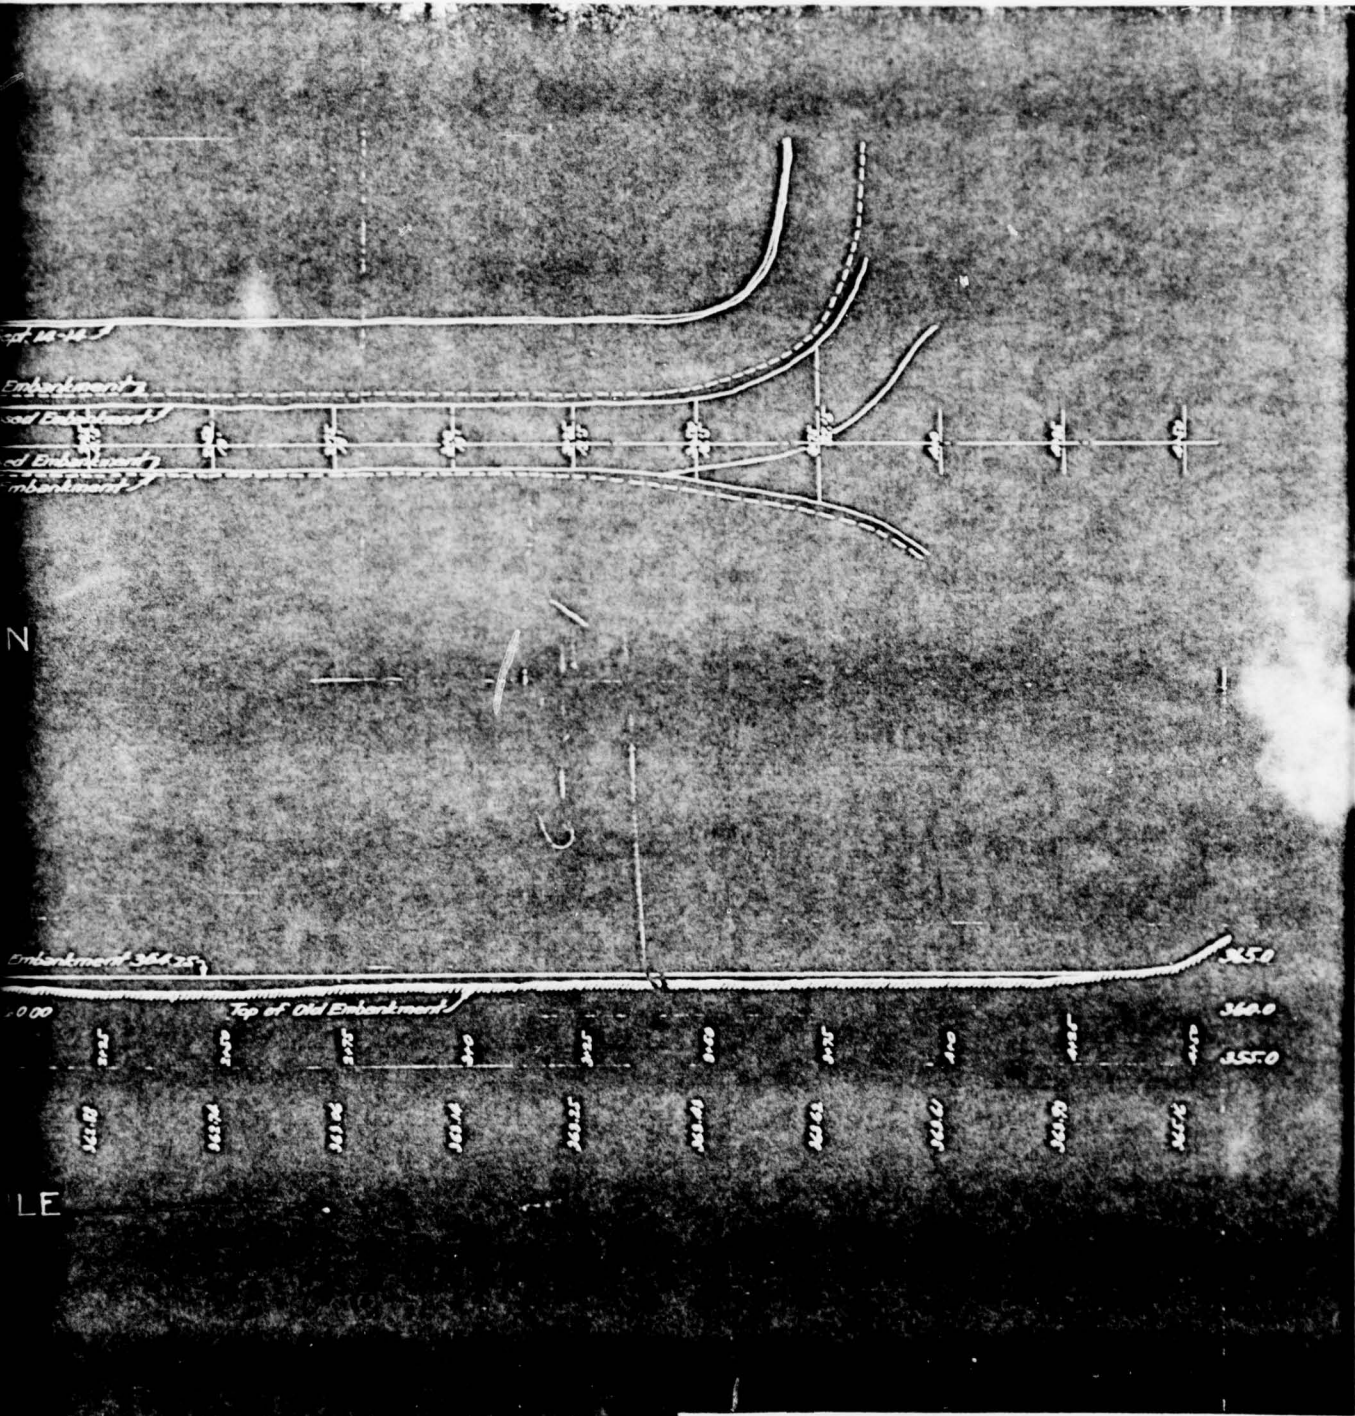
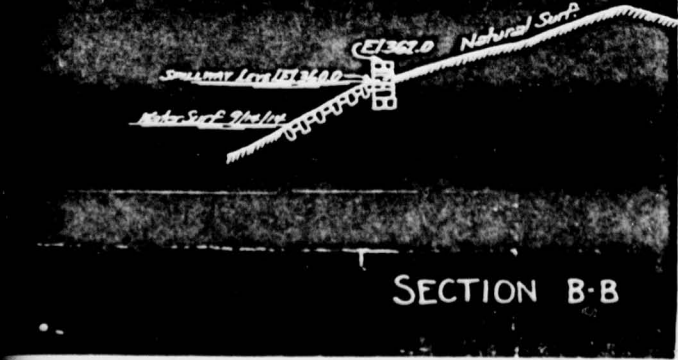
PLAN AND PROFILE OF DAM & APPURTENANT STRUCTURES INDIAN RUN DAM (BIRDSBORO RESERVOIR)		
NAT. ID NO. PA.00713		BERKS COUNTY
DATA OBTAINED FROM WM. H. DECHANT, & SON, CE PLAN NO. 2860, DATED SEPT., 1914		
		PLATE 2

b. Design Features. The principal design features have been obtained from post-construction reports, Reference No. 1, and from results of the visual inspection performed on 29 August 1978. A plan view of the dam and cross-section of the intake tower are enclosed as Plates 2 and 3, Appendix E, respectively. No cross-sections of the embankment are available. The upstream and downstream slopes presented in Section 1.3 of this report were confirmed in the field by use of an Abney level.

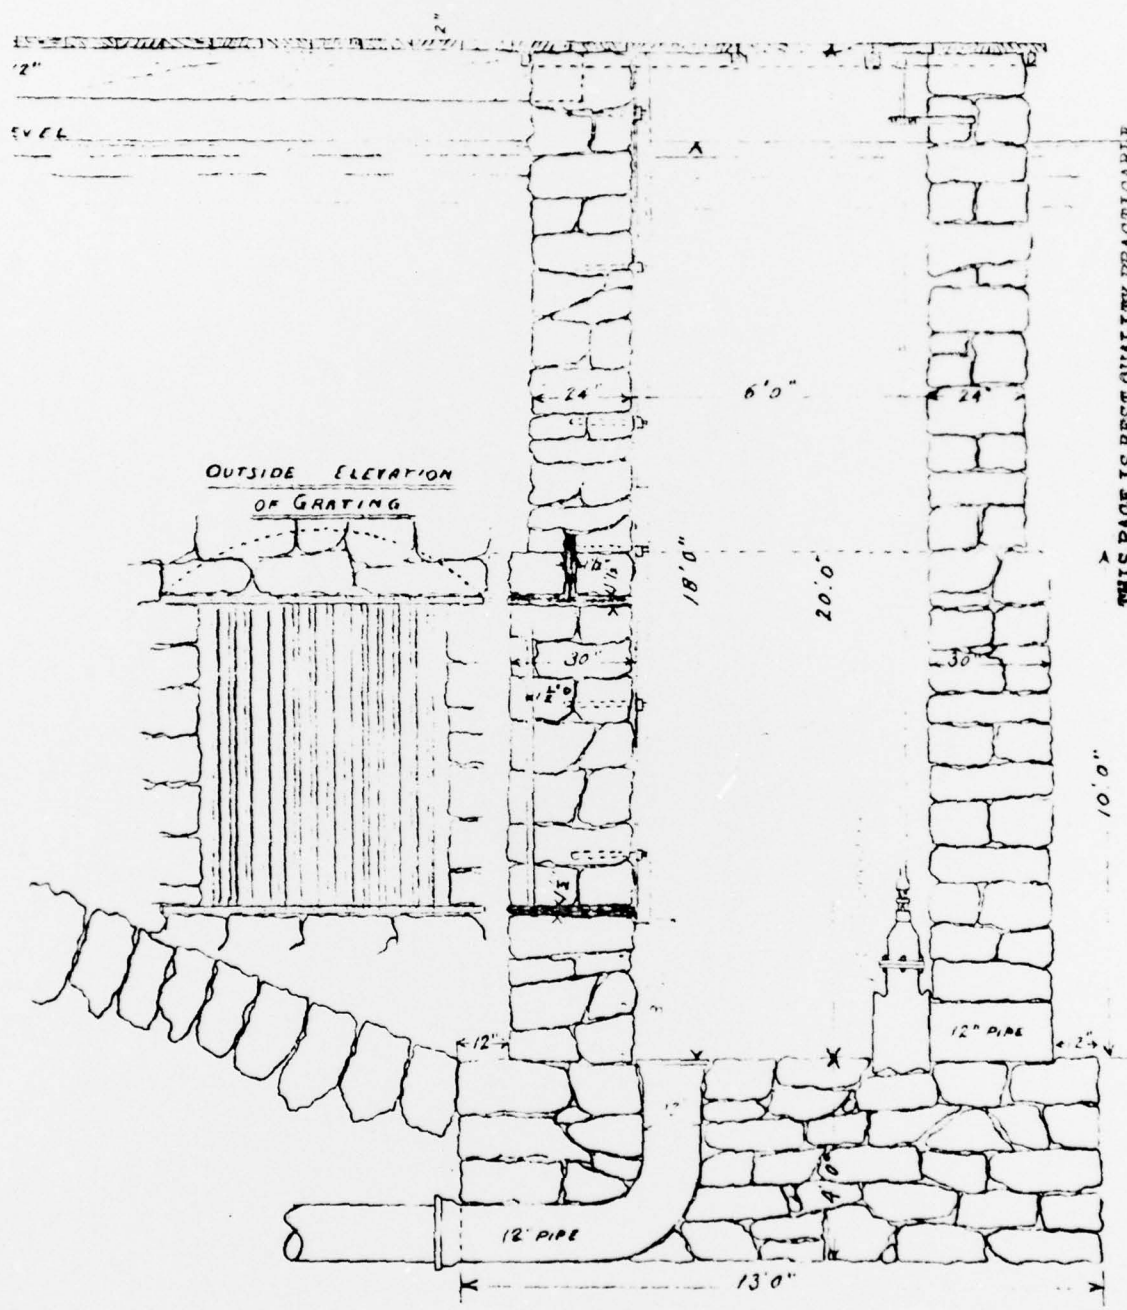
<p>PROFILE OF INTAKE STRUCTURE INDIAN RUN DAM (BIRDSBORO RESERVOIR)</p>		
<p>NAT. ID NO. PA.00713</p>		<p>BERKS COUNTY</p>
<p>DATA OBTAINED FROM DRAWING PREPARED BY ISSAC S. CASSIN, DATED APRIL, 1883</p>		
		<p>PLATE 3</p>

As shown on Plate 3, Appendix E, the intake structure is a masonry tower with a water intake approximately 6.5 feet high and 5.5 feet wide, protected by a grating. It is reported that a 12-inch water supply intake pipe is located at the base of the tower which supplies the town of Birdsboro. A branch in the 12-inch line serves as a pond drain. As noted on Plate 3, there is also an upstream intake orifice and valve at the base of the tower. It is reported by the Owner's representatives that this valve is no longer operable.
